**THE NEWARK MUSEUM
POLHEMUS HOUSE ARCHITECTURAL SALVAGE
January 5, 2012**

Polhemus House HSR Interior Inventory

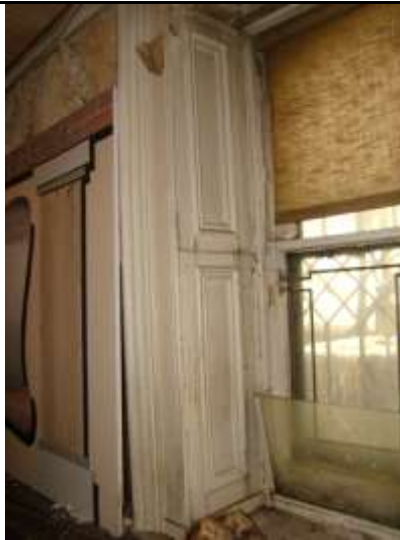
Description 11" wide x 56" high. Two stacked vertically. At windows E01 and E02.

H03 4EA Missing, Altered, or Broken Hardware

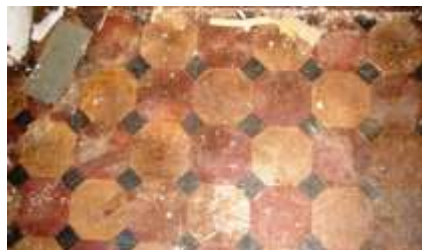
Description 4' x 9' perimeter. Hexagonal polychrome (red and tan) tiles with square black tiles inset diagonally.

T01 36SF Damaged or Broken Tiles

T02 9SF Open/Deteriorated Joints in Tile Work

T04 36SF

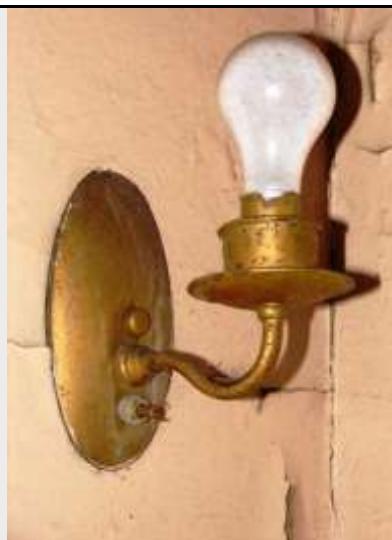
Description Wall Sconces

L02 2EA Historic Light Fixture
Inoperable/Missing

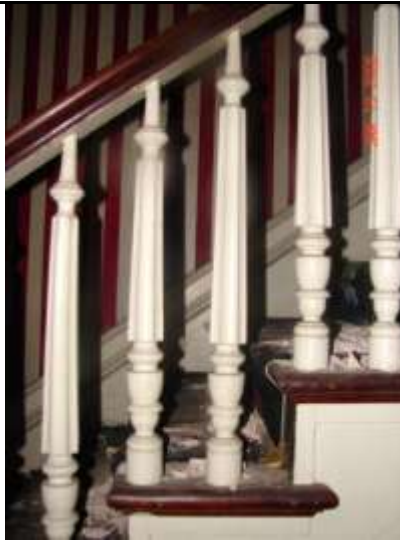
Description 2'4" high, 2.25" diameter

Conditions
W01 8SF Wood Loss

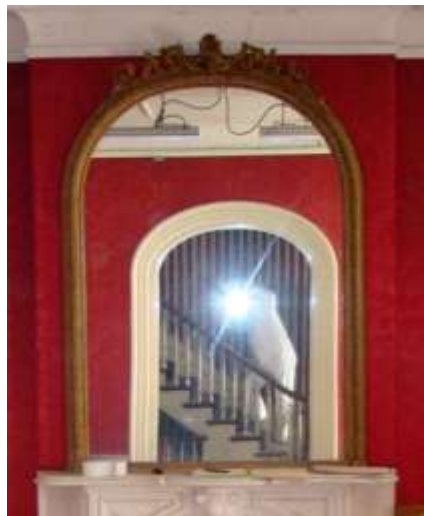
Description 5' 0" x 7' 4" with 3" wide frame

W03 2SI Missing Wood Element

W06 10SF Soiling (Wood)

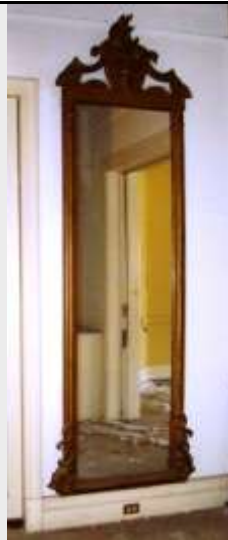
Alteration Moved to Anteroom

Q05 IEA Misc. Element Relocated

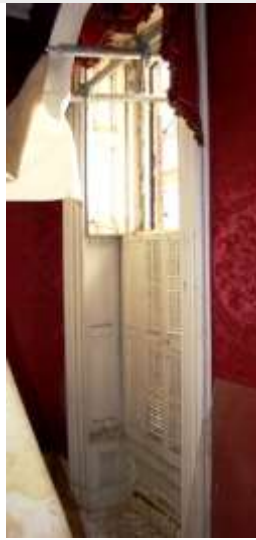
Description 20" x 4'2" each. 4 per window. Blinds recess into window jambs, hidden blind is louvered. Knobs are ceramic (1 1/8"). At Windows E03 and E04.

H01 4EA Inoperable/Inappropriate Hardware

H02 4EA Inappropriate Finish

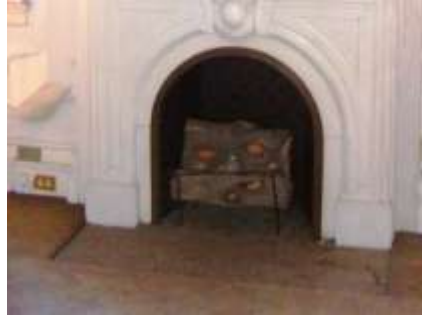
Description Tile dimensions: 1.25" x 4".
Hearth projects 1' from fireplace.

T04 10SF

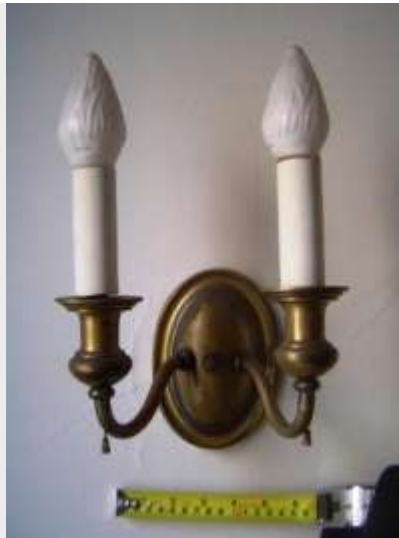
Description Damaged and inoperable wall sconce

L02 4EA Historic Light Fixture
Inoperable/Missing

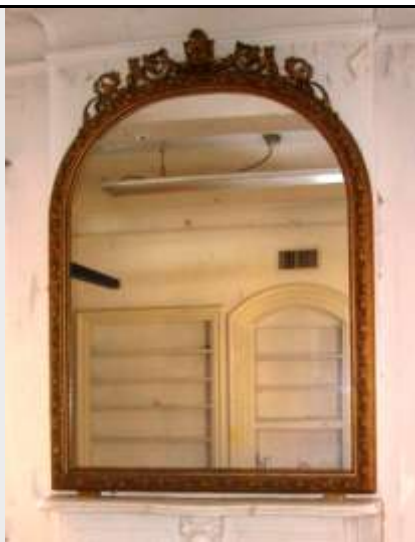
Description 5'0" x 7'0". Same as in parlor.

W06 I0SF Soiling (Wood)

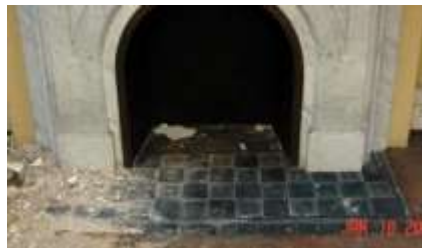
Description 5'4" x 1'11"

T01 5EA Damaged or Broken Tiles

T02 10SF Open/Deteriorated Joints in Tile Work

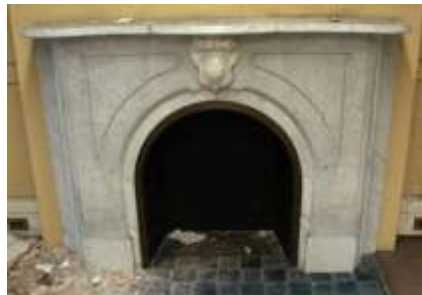
Description 5'4" x 3'11". Circa 1863 marble mantelpiece removed from 2nd floor bedroom in 1966 renovation and installed in dining room.

Alteration Original 1883 wood and tile mantelpiece replaced in 1949 and again in 1966.

Q04 IEA Misc. Missing Element

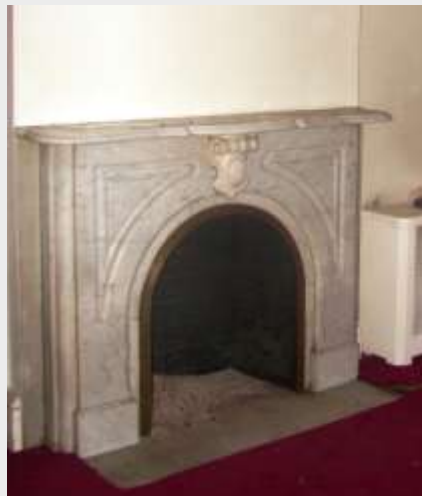
Description 5'-2" x 3'-10"

S02 26SF Soiled, Marred Surface

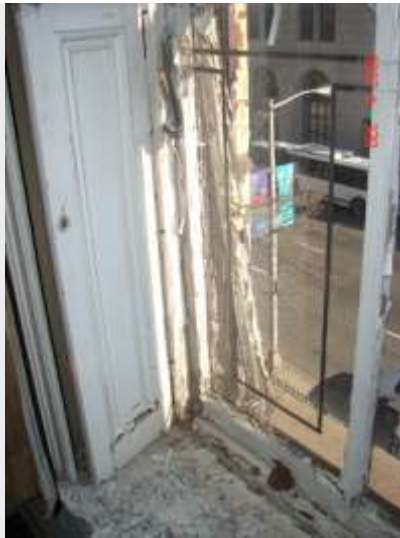
Description Two blinds on each side, one with recessed profiled panel and one louvered. Each panel 11" x 42" high. At Window E08.

H01 4EA Inoperable/Inappropriate Hardware

H03 2EA Missing, Altered, or Broken Hardware

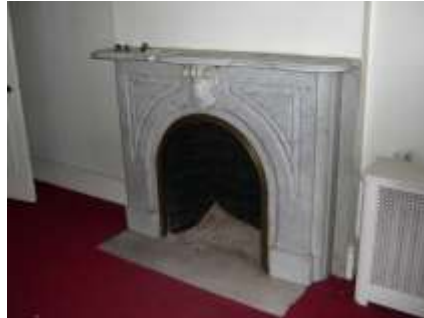
Description 5'4" x 5'11"

S02 32SF Soiled, Marred Surface

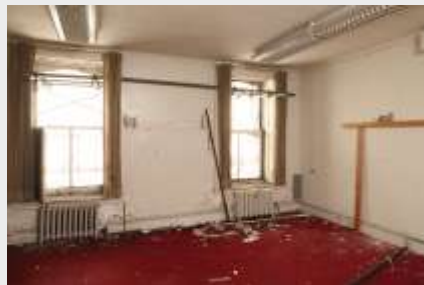
Description Two blinds on each side, one with recessed profiled panel and one louvered. Each panel 11" x 42" high. At Windows E09 and E10.

H03 4EA Missing, Altered, or Broken Hardware

H04 8EA Corroded or Inoperable Original Hardware

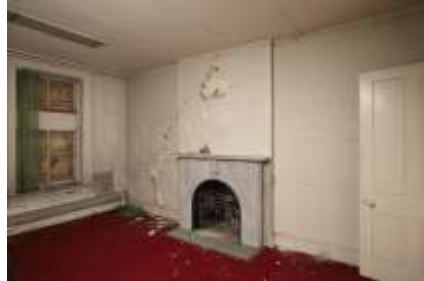
Description 5'4" x 5'11"

S02 32SF Soiled, Marred Surface

S04 10LF Open/Deteriorated Joints In Stone Work
